SAN FERNANDO, CALIFORNIA,
EARTHQUAKE OF
9 FEBRUARY 1971

GORDON B. OAKESHOTT, *Editor*
CALIFORNIA DIVISION OF MINES AND GEOLOGY

BULLETIN 196
California Division of Mines and Geology
Resources Building, Sacramento, California

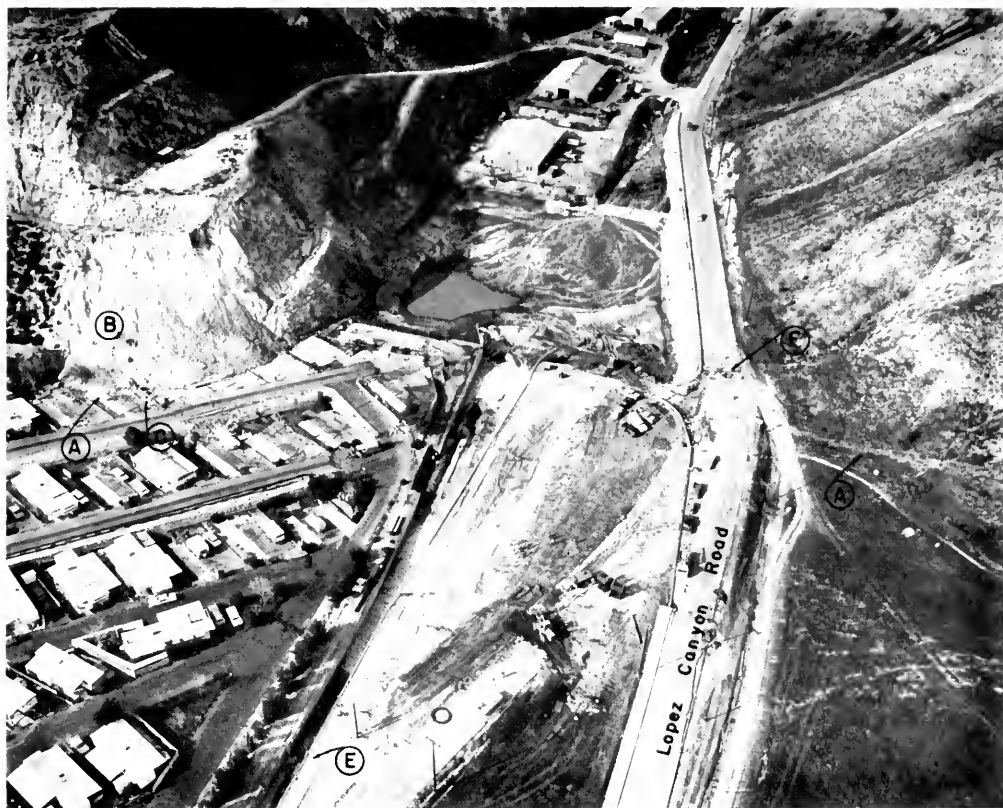
Photo 2. Low-altitude oblique aerial photo of the mouth of Lopez Canyon. Lettered localities: (A) scarp of the Tujunga fault segment; (B) rockfall caused by earthquake; (C) site of trench 8 in Blue Star Trailer Park; (D) bedding in Madela Formation; (E) damage to flood control channel; (F) 38 cm (15-inch) left-lateral displacement of white line on Lopez Canyon Road. Photo courtesy of the Los Angeles Department of Building and Safety.

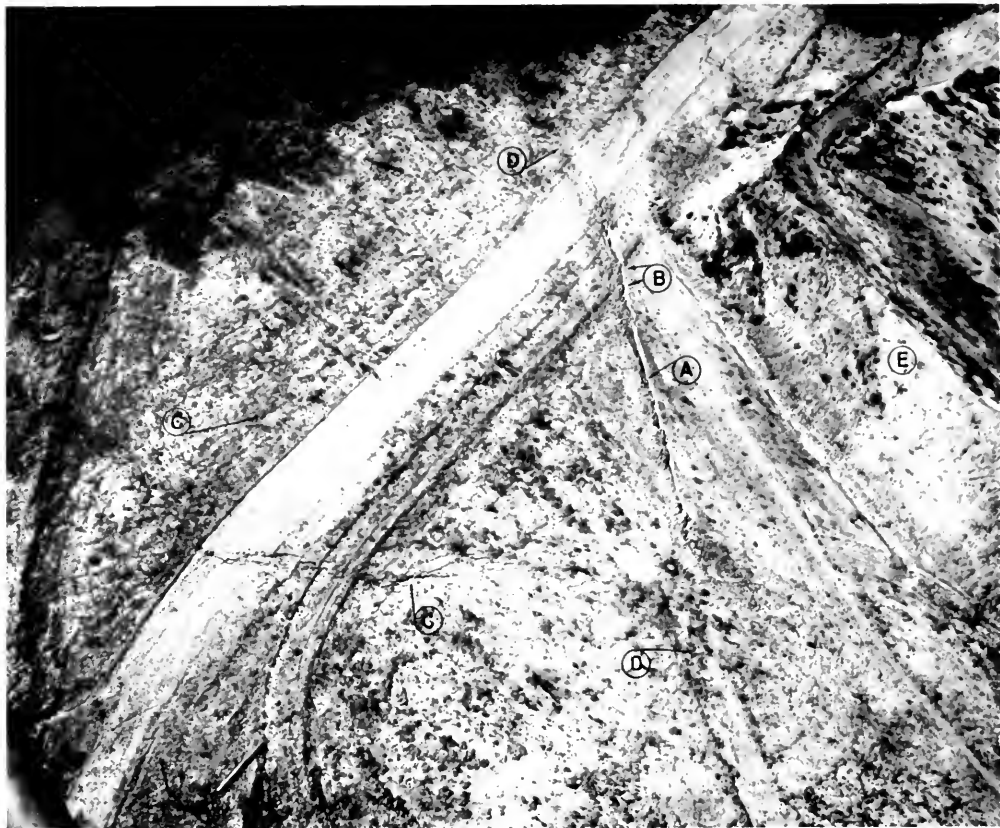
Photo 6. Low-altitude aerial photo of the Oak Hill fault scarp in Lopez Canyon. Lettered localities: (A) 80 cm (32-inch) high scarp in bedrock striking N. 75° W., dipping 62° N; (B) dirt ridge offset left laterally about 85 cm (33 inches); (C) settling cracks possibly delineating the contact between bedrock at shallow depth and deeper fill and alluvium; (D) mole track or hump where faulting occurred in loose fill and alluvium; (E) sandstone, siltstone, and conglomerate beds of the Towsley/Pico Formation whose attitude is similar but not identical to that of the fault. Photo courtesy of the Los Angeles Department of Building and Safety.

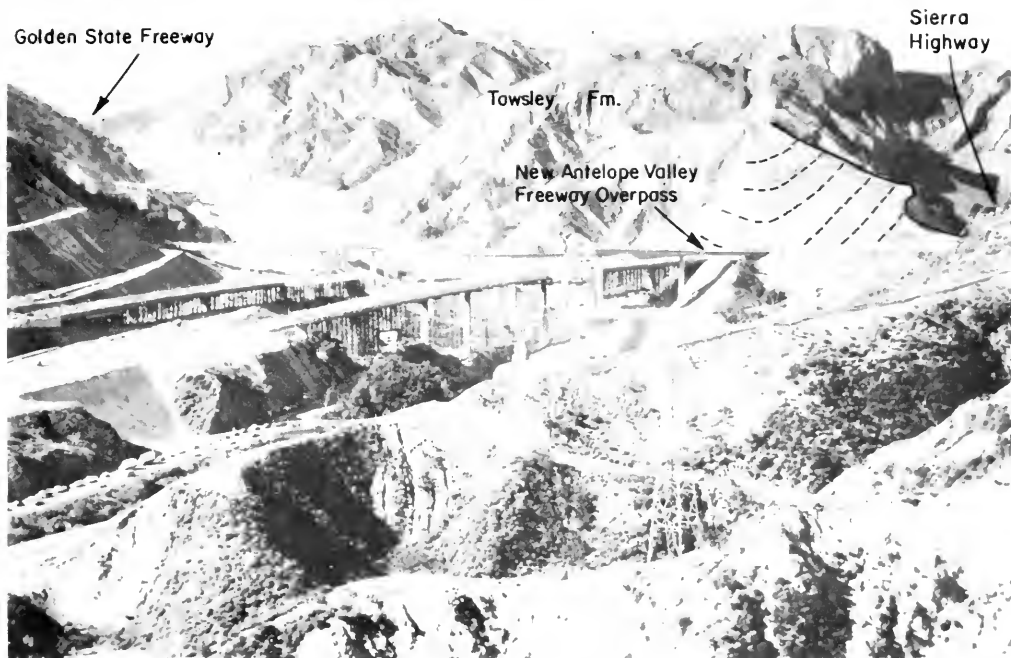
Photo 1. Collapsed overpass of the Antelope Valley Freeway, just north of the Sierra Highway intersection with the Golden State Freeway. Beds of the Towsley Formation are strongly deformed in this area, and a tightly folded syncline is well exposed in the adjacent cut. View is north.

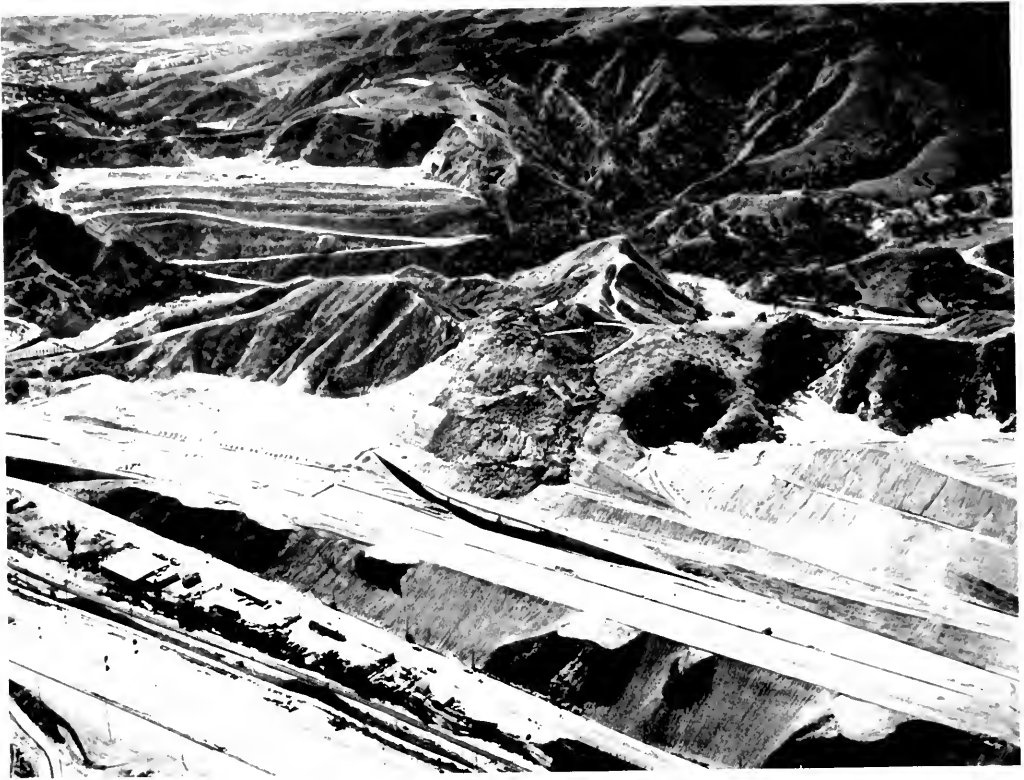
Photo 2. Earthquake-triggered landslide along the unfinished southbound lane of the Golden State Freeway, San Fernando Pass area. Weak, fine-grained, clastic beds in the Towsley Formation lurched parallel to the strike of beds and slid down along the dip (see photo 3). Failure took place during first strong shaking. Flat area in left background is a Los Angeles County sanitary land-fill. View is southwest. Photo courtesy of the Grading Section of the Los Angeles Department of Building and Safety.

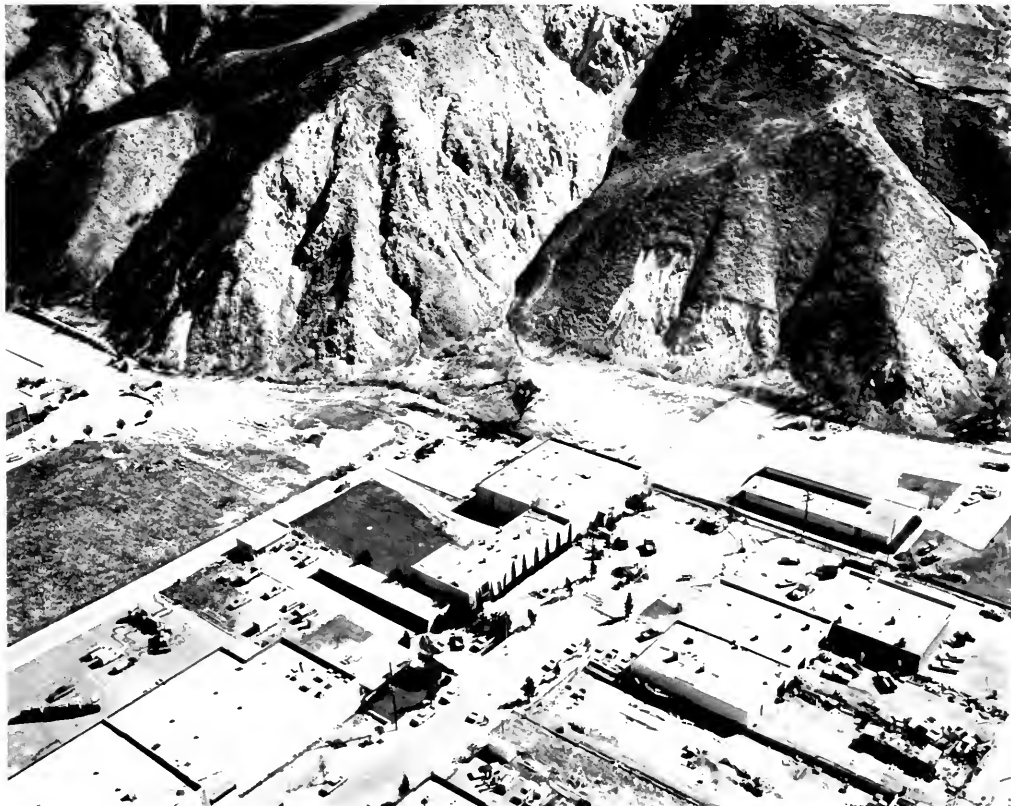
Photo 1. Abundant shallow small slope failures in Towsley and Madelo Formations near San Fernando Ranger Station. Photo courtesy of Los Angeles Department of Building and Safety.

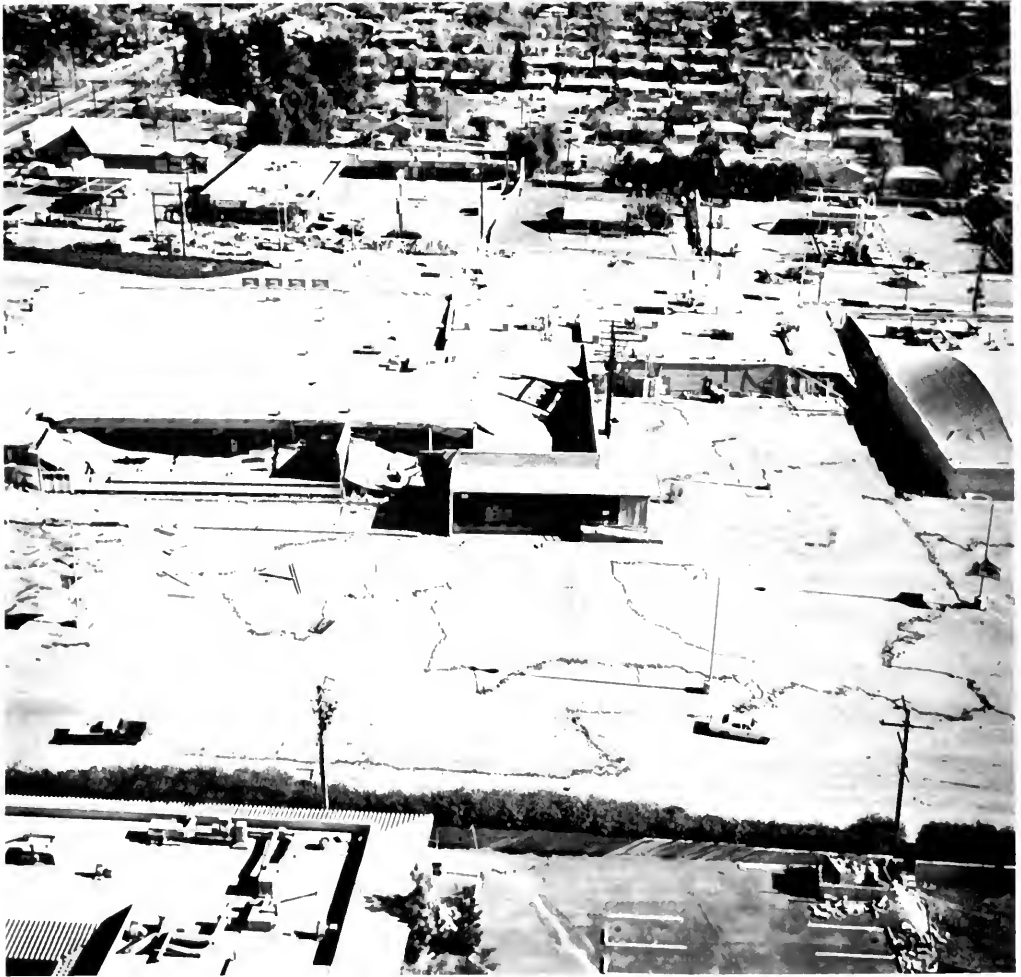
Photo 5. Boys Market, at the corner of Glenoaks Boulevard and Hubbard Street, collapsed as a result of ground displacement and ground lurching in combination with intense shaking. Photo courtesy of Robert E. Wolloce, U.S. Geological Survey.

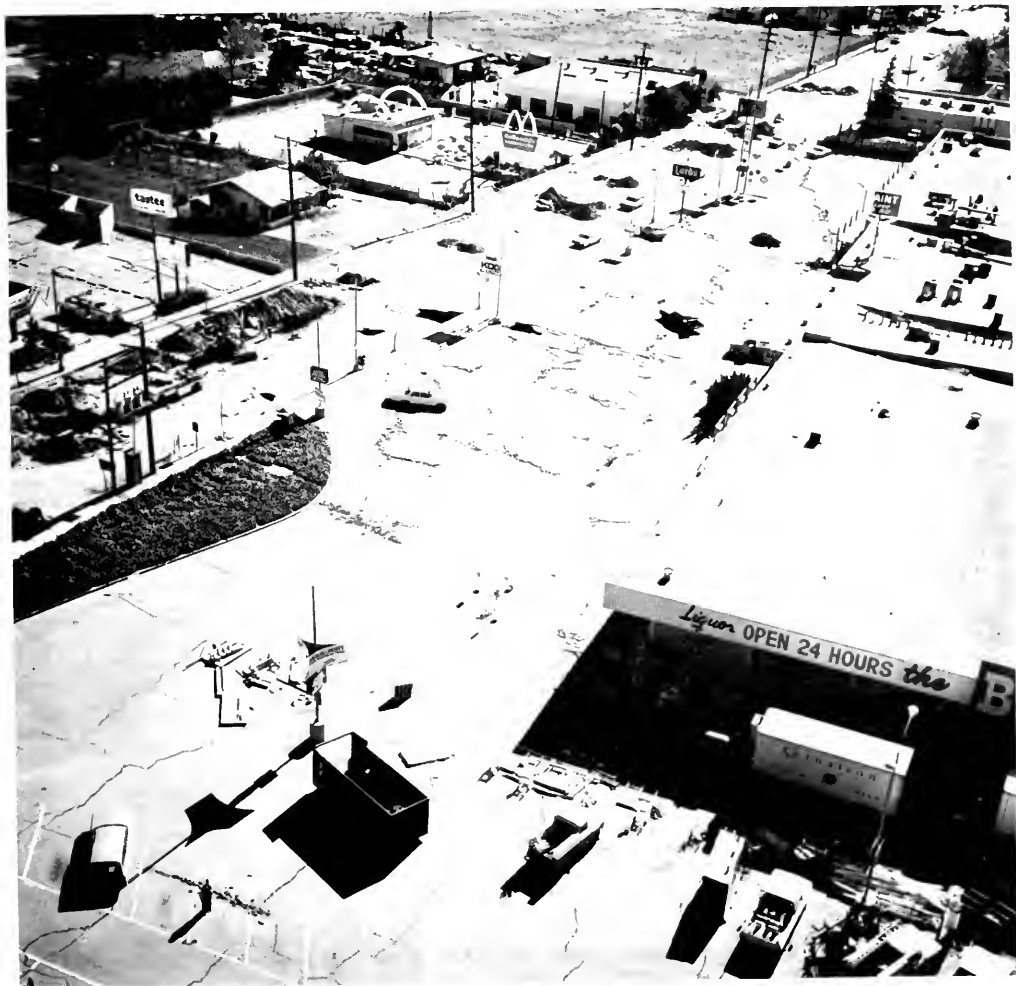
Photo 6. The commercial area at the southwest corner of Glenoaks Boulevard and Hubbard Street was damaged by displacement, lurching, and strong ground motion. Photo courtesy of Robert E. Wallace, U. S. Geological Survey.

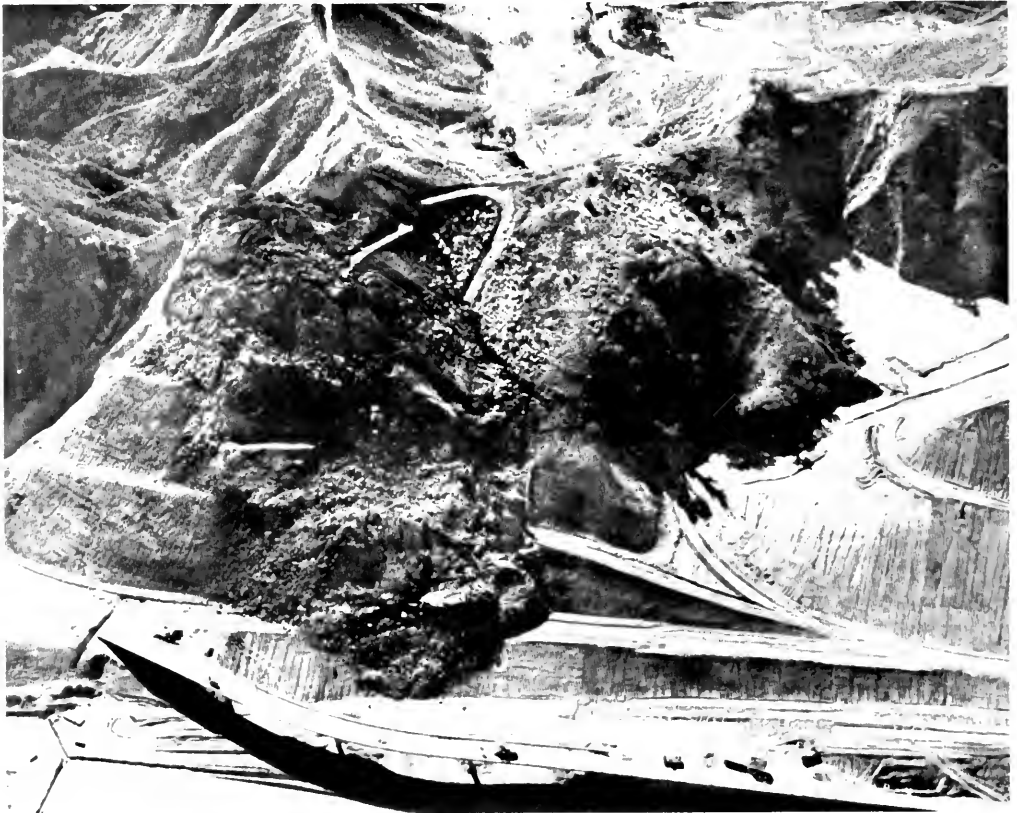
Photo 1. Cut slope failure on Route 5 between route 5/14 and Route 5/210 Interchanges

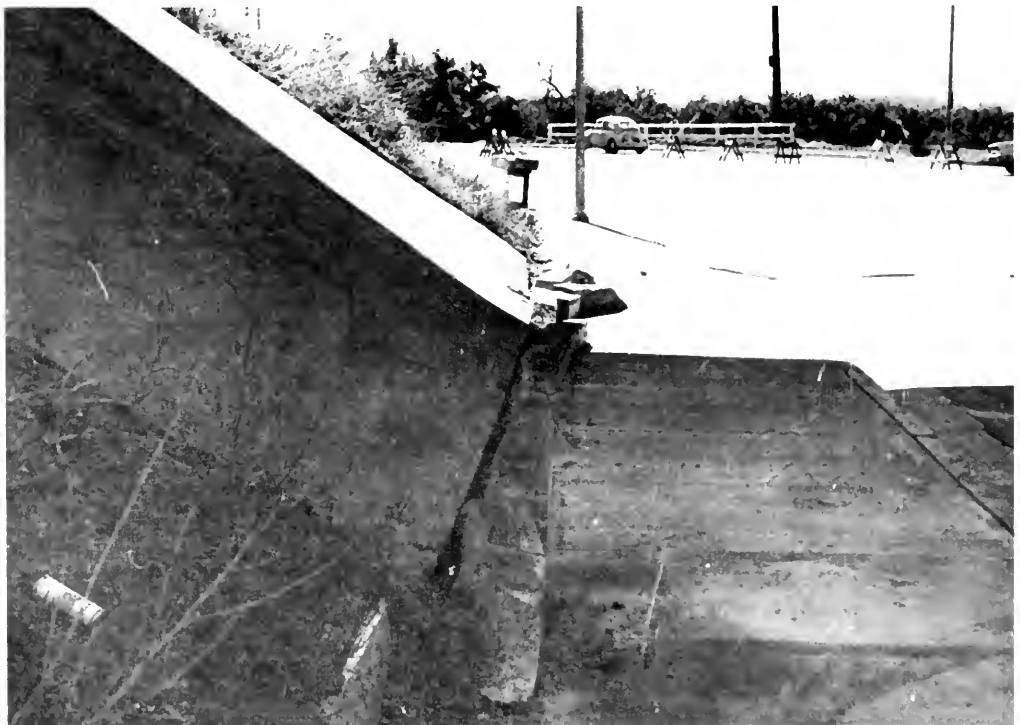
Photo 4. Concrete curbs broken by lateral movement of slope paving during fill movement.

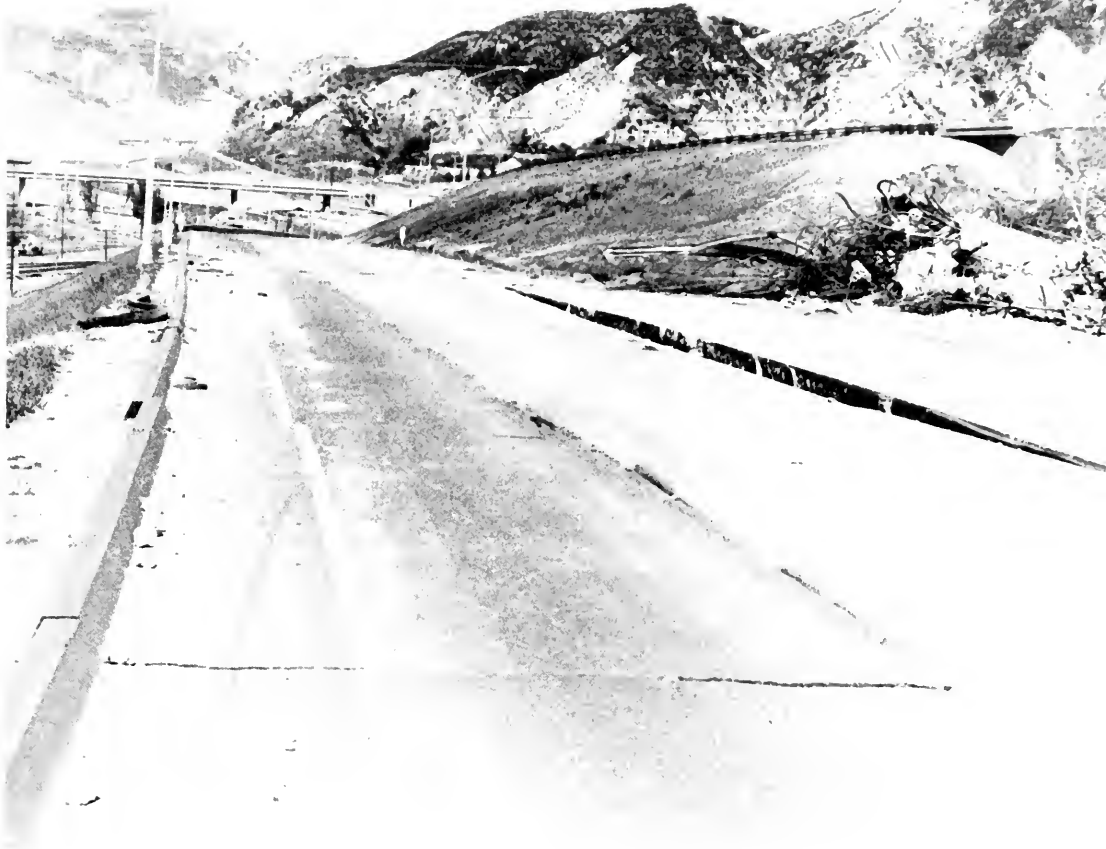
Photo 5. Vertical and horizontal offsets in concrete pavement slabs caused by shear failure in fill material.

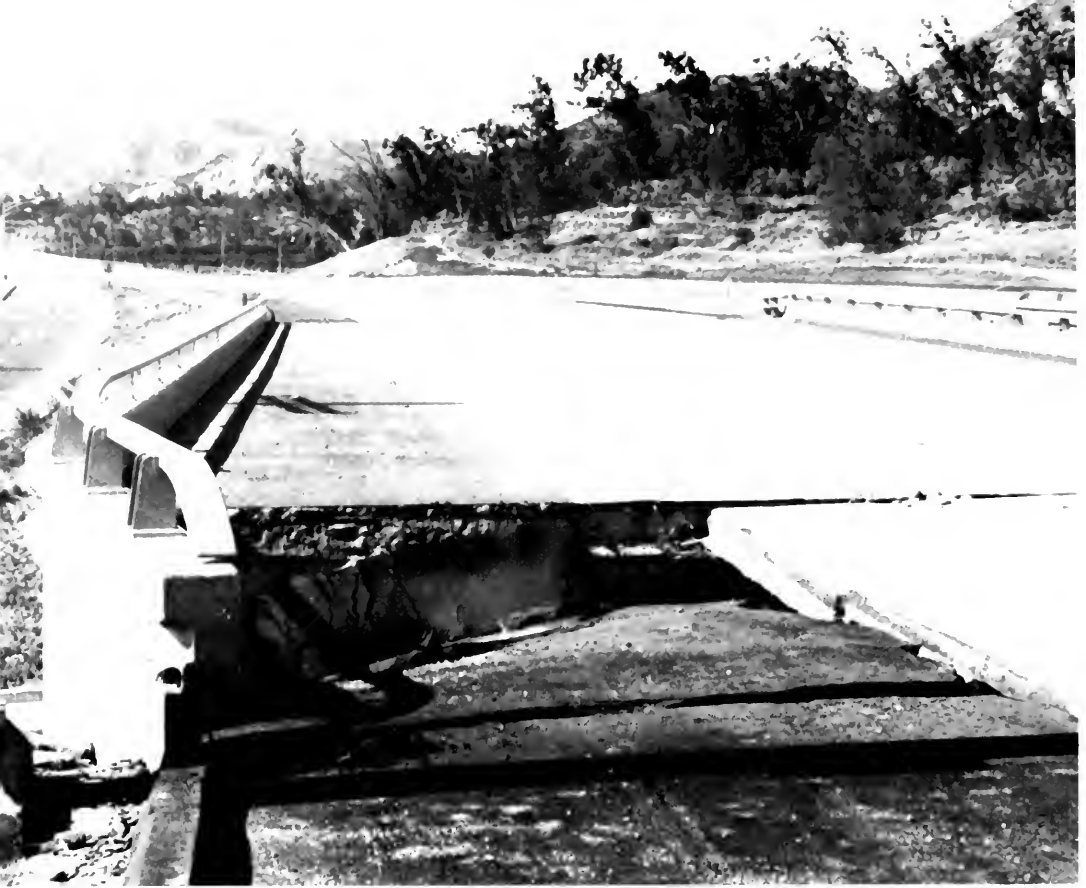
Photo 3. Settlement of bridge approach fill on Route 210.

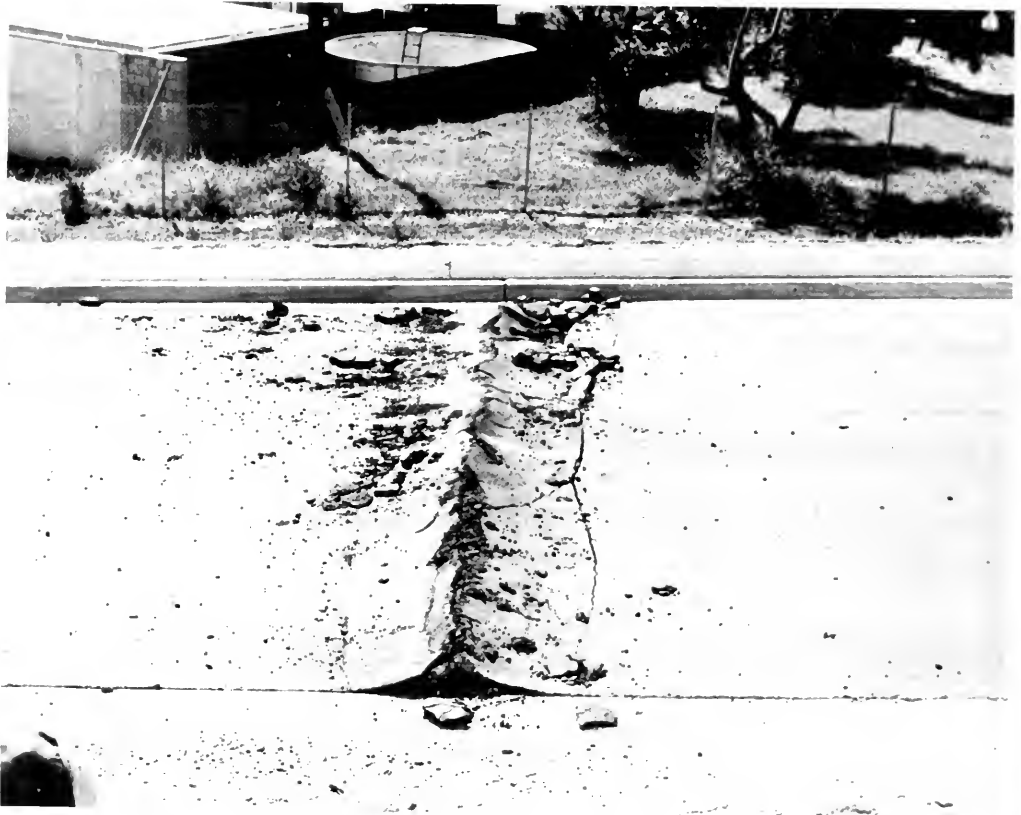
Photo 11. Compression buckle in asphaltic concrete ramp pavement on Route 210.

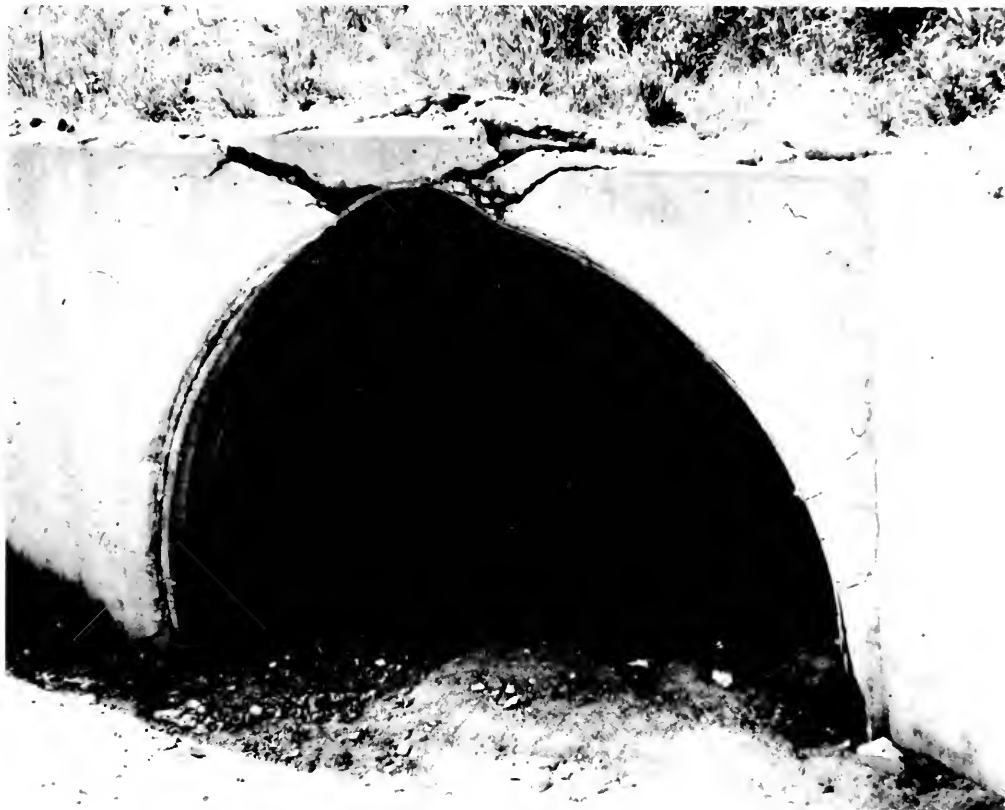
Photo 12. Fractured culvert headwall on Route 5.

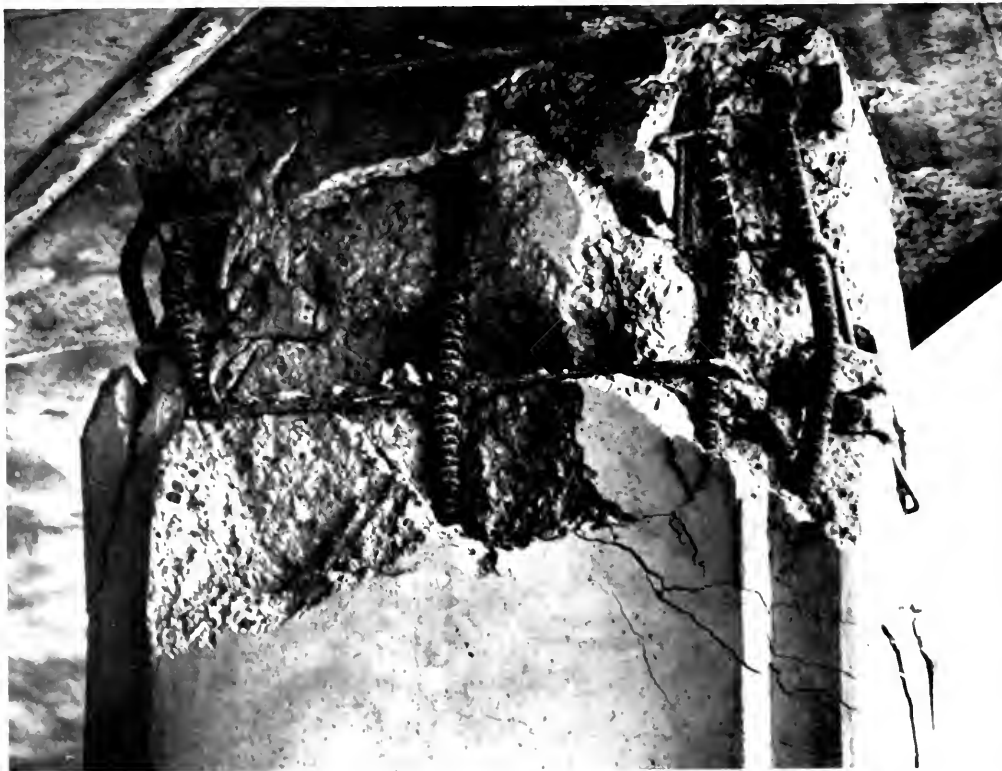
Photo 7. Flexural damage in column of San Fernando Road overhead [2].

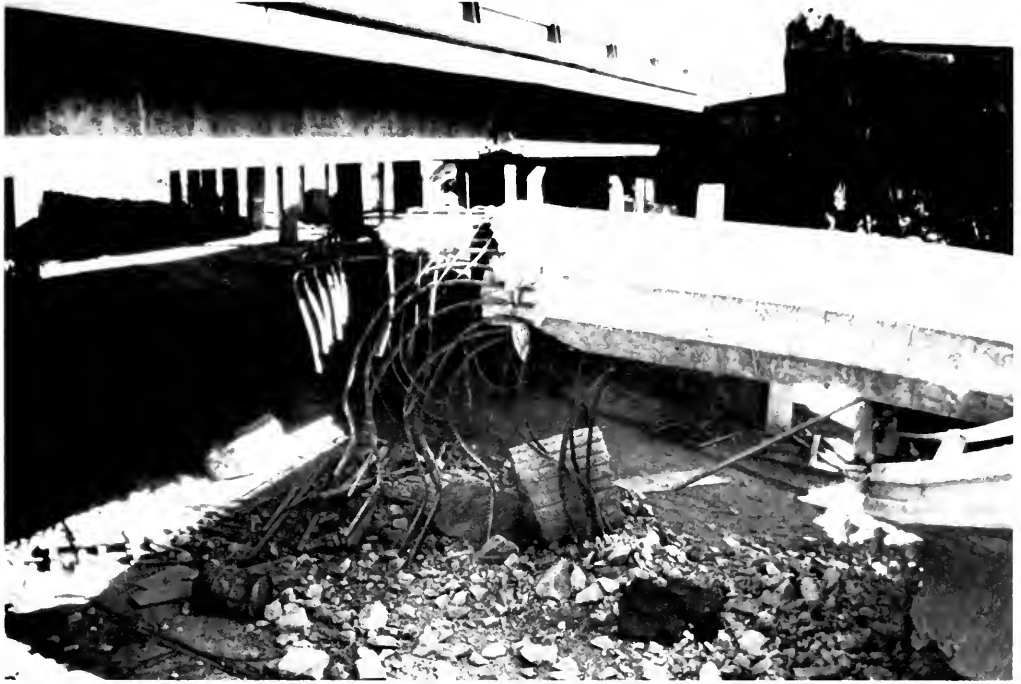
Photo 13. Column of overcrossing at the Golden State Freeway and Foothill Freeway interchange [4].

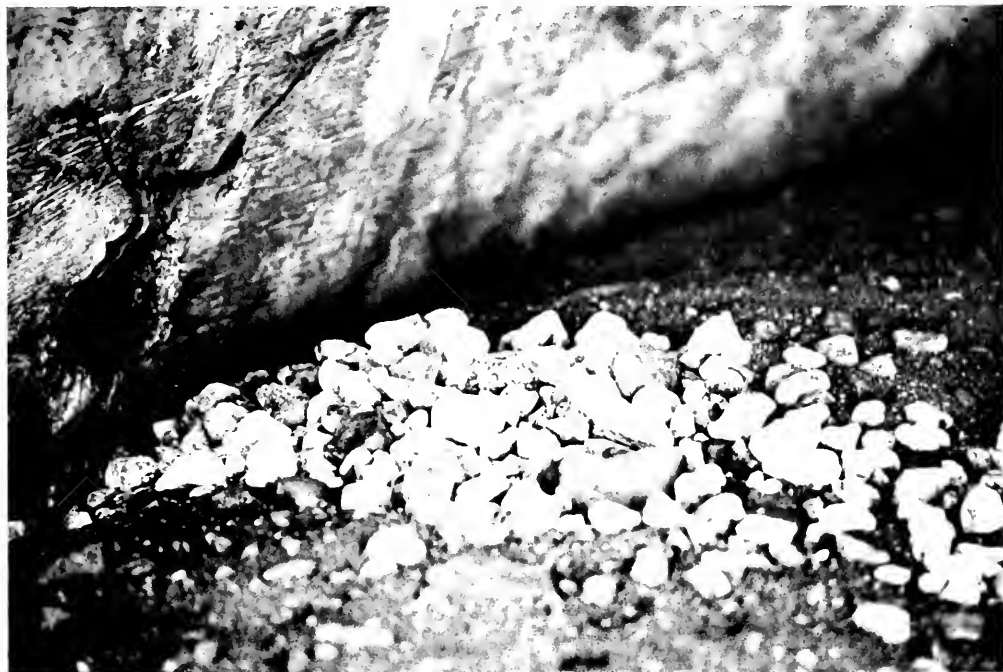
Photo 26. View showing crushed rock forced out of weep hole. Bledsoe Street undercrossing of Foothill Freeway [36].
